## QUARTZDYNE, INC.

## RECENT IMPROVEMENTS TO MAKE QUARTZDYNE® PRESSURE TRANSDUCERS MORE RUGGED

May 1999

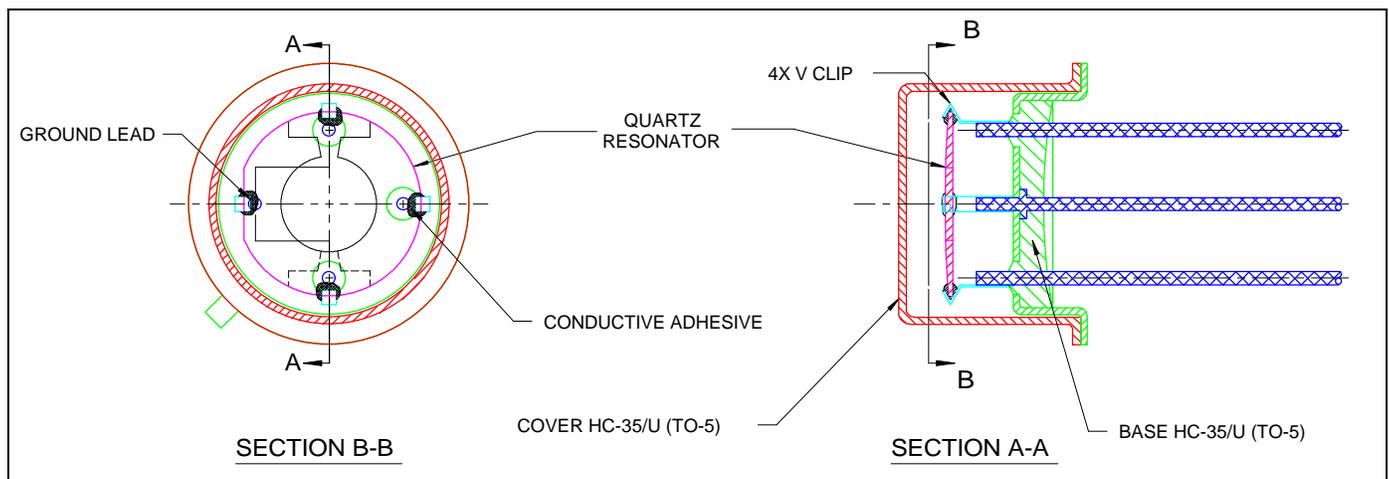
The majority of the improvement arises from toughening the mounting joints within the temperature and reference crystals. As illustrated in Figure 1, a thin quartz resonator is mounted via four V-clips. An electrically conductive adhesive is responsible for making contact between the V-clip and the quartz resonator: two of the joints are necessary for oscillation, while the other two are for structural mounting only.

Figure 1: Cross Section of a Temperature or Reference Oscillator Crystal

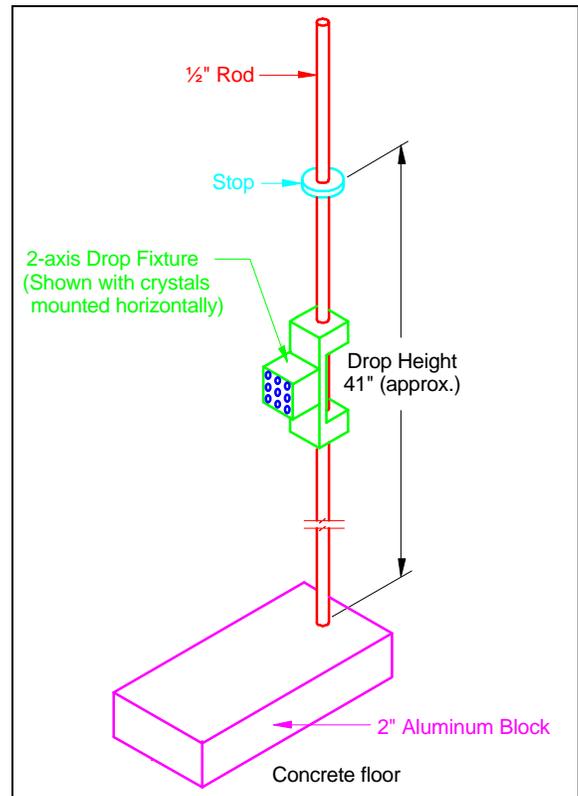
In order to reduce, or possibly eliminate, temperature and reference crystal failures, we created a destructive test to qualify and quantify proposed improvements to the crystals. In Figure 2, we modified our drop stand to hold nine crystals simultaneously in a cube. The testing apparatus shown in Figure 2 was placed directly on a concrete floor. The fixture was allowed to drop directly onto a 2" thick aluminum plate with no padding.

Figure 2: Drop Stand for Shocking Crystals

The resulting high frequency, metal to metal, impact-type shocks were not measured using an accelerometer, because it proved to be inadequate in this application. The accelerometer actually broke after several drops at approximately 6 inches! Prior to failing, however, its signal clipped at 10,000 g! After discarding the accelerometer, we set the drop height to roughly 41 inches. At this height, we estimate several hundred thousand g's are transferred to the crystal.

In order to establish the nominal shock resistance baseline of crystals manufactured throughout the 1991 - 1996 timeframe, we selected both temperature and reference crystals from past lots. After scanning the crystals using an HP 3577A network analyzer, 25 drops were delivered to each crystal, each shock taking place parallel to the surface of the quartz resonator. The crystals were tested between each sequence of 25 drops. Failure criteria was based on a significant increase in impedance.

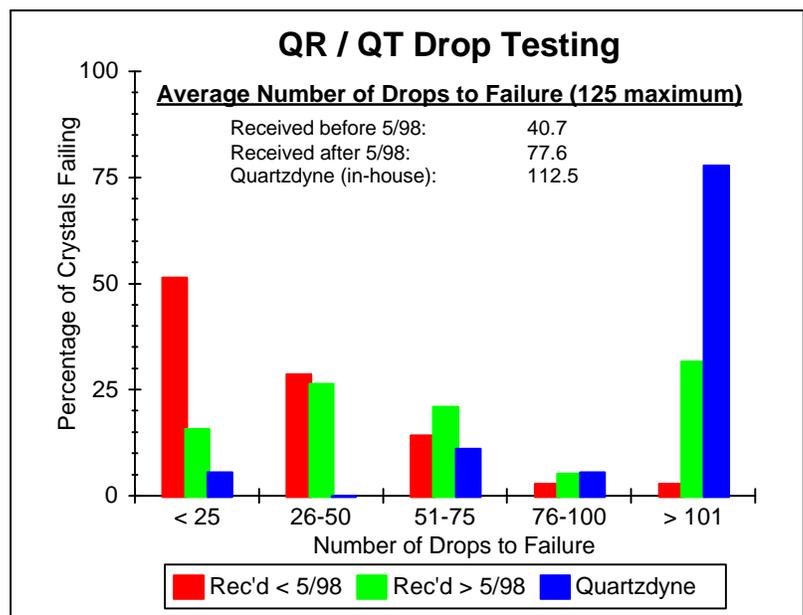
In Figure 3, the “Rec'd < 5/98” bar (red on color copies) indicates the results, showing that over half of these old-style crystals had failed by the first 25 drops, and another 25% had failed by the second 25 drops! There was, however, a very small percentage that survived over 100 drops. The data was sorted according to the lot date code, and according to the crystal type, but neither correlated with crystal robustness.

Figure 3: Drop Testing Results

In order to achieve more uniform, high end results, Quartzdyne drafted a workmanship standard in April 1998 to govern the physical appearance of the internal joints in the temperature and reference crystals. Preliminary lots provided to Quartzdyne based upon this workmanship standard showed an average improvement of 90% in the average number of drops a canned crystal will withstand before failure. These crystals are shown as "Rec'd > 5/98" (green in color copies) in Figure 3.

Quartzdyne has recently brought the capability of manufacturing temperature and reference crystals in-house. Additional process changes in the construction of these crystals has led to the results shown as "Quartzdyne" (blue in color copies) in Figure 3. We were able to accomplish this improved robustness without sacrificing any long-term aging of the temperature and reference crystals.

The "Rec'd > 5/98" (green) crystals are currently incorporated into all standard Quartzdyne® pressure transducers, and are adequate for normal wire-line and permanently installed applications. The "Quartzdyne" (blue) crystals are included in selected units upon request, where an extreme shock and vibration environment is expected (see Appendix).

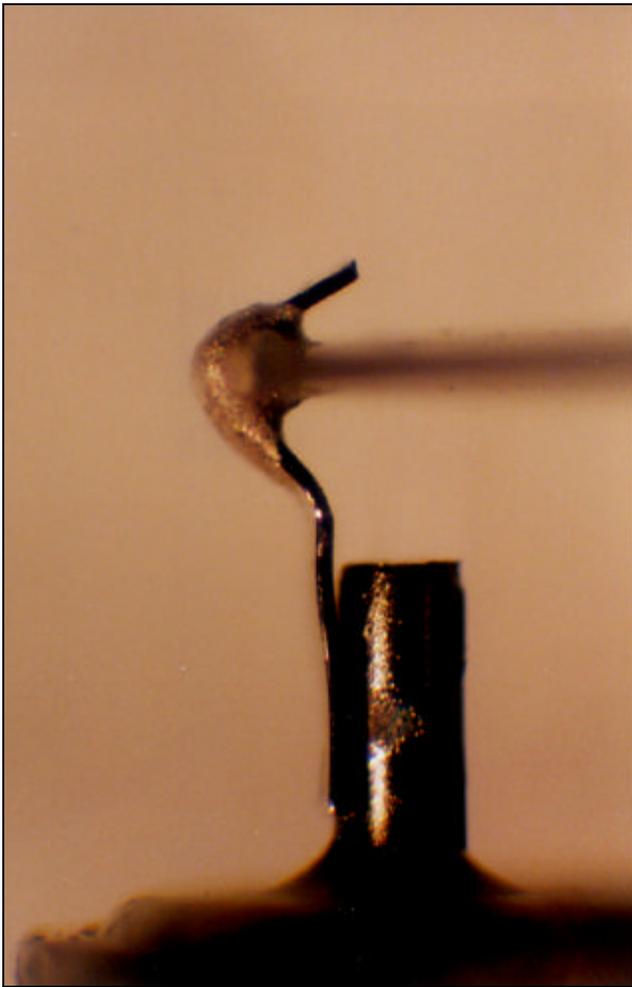
Figure 4: Photograph of side view showing adequate adhesive fillets.

Upon opening the failed specimens, we overwhelmingly observed cracked adhesive between the V-clip and the resonator. Furthermore, when comparing the three best crystals (100+ drops with no failure), with the three worst crystals (<25 drops to failure), it was very apparent that the quantity and quality of conductive adhesive over the joint is absolutely critical. Those crystals that survived had an adequate amount of adhesive over the joint, while those crystals that failed early exhibited only a very small amount of conductive adhesive over the joint. See the comparative photographs shown in Figure 4 and Figure 5.

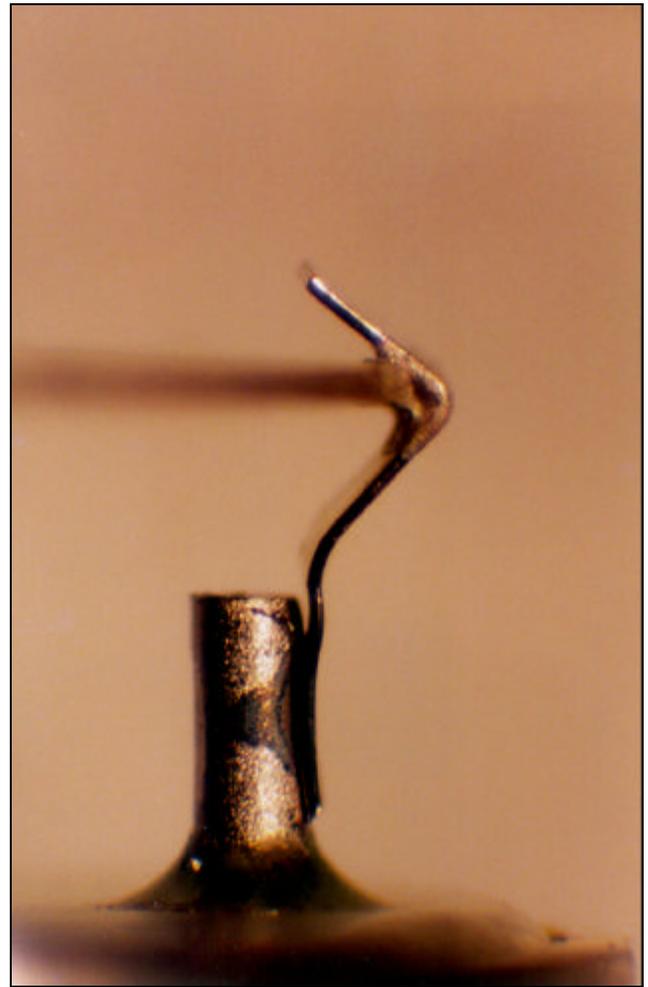
Figure 5: Photograph of side view showing insufficient adhesive.

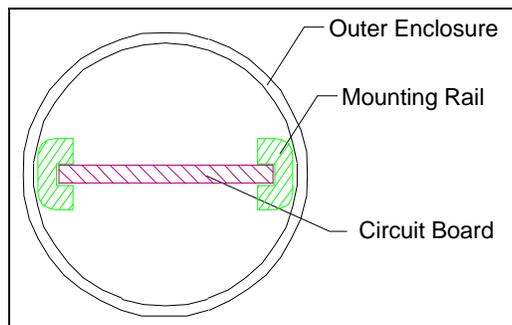
The final trademark of the ruggedized Series QU is the circuit board mounting scheme. Unlike other versions, which hold the circuit at the ends or at selected locations in the middle, the ruggedized Series QU nestles the circuit in a slot along its entire length (see Figure 6). Conformal coating along the edges and stiff springs located at the ends prevent the board from rattling in the slot. This edgewise support has proven to be superior in severe shock and vibration environments.

Figure 6: Cross section of circuit mounting

Unfortunately, not all of our circuit boards can be mounted in this fashion. For example the large through-hole components on the Series QL require a wider PC board, which will not fit inside the slots in a 1" O.D. enclosure. Our future high temperature products will include a hybrid circuit, which will have superior shock resistance, due to its small size and mass.
