Reliability Statistics of Quartzdyne® Pressure Transducers

April 2018

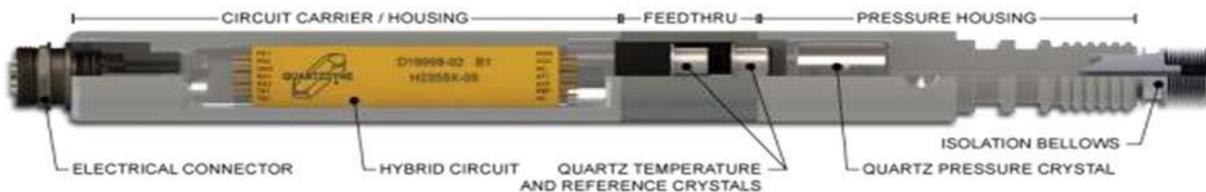
Figure 1: Cross-Section of Typical Quartzdyne Pressure Transducer with Key Elements Identified

The quartz pressure and temperature crystals change frequency to measure pressure and temperature; the quartz reference crystal is used as a clock. All three crystals are temperature-sensitive in varying degrees, but only the pressure crystal is hydrostatically exposed to pressure. As depicted in Figure 1, the temperature and reference crystals are of similar construction (packaged in metal TO-5 cans), while the pressure crystal is a monolithic quartz crystal, capable of withstanding high compressive stresses.

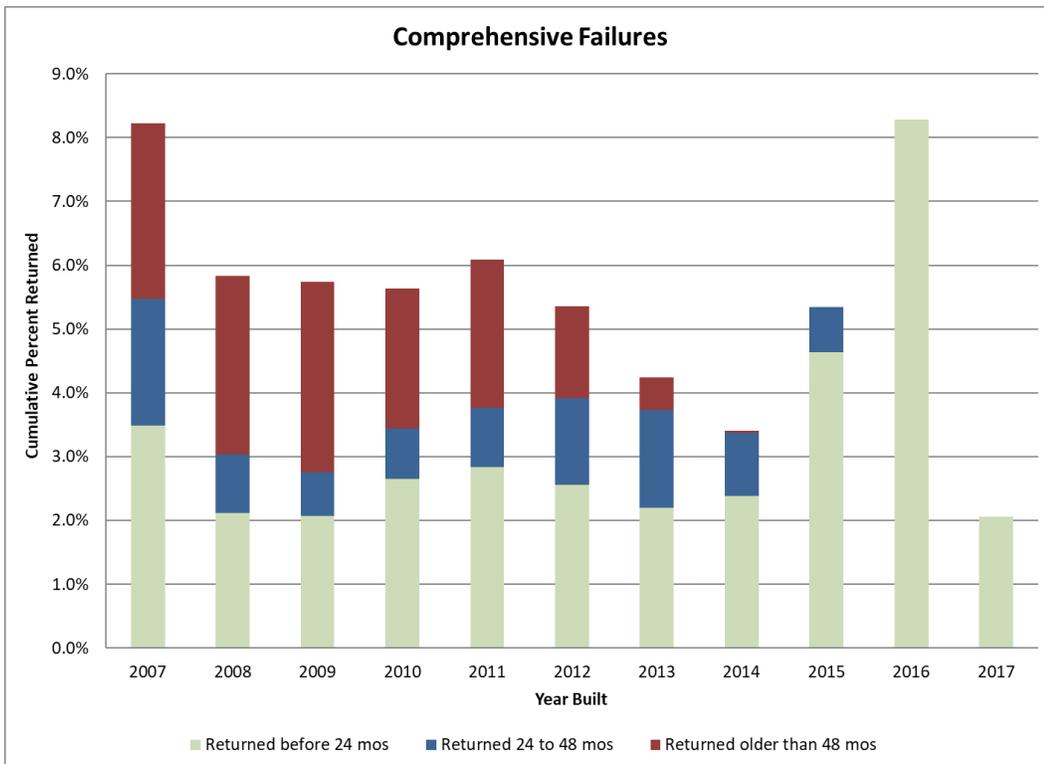
Figure 2: Overall Reliability

Quartzdyne sells transducers into three primary markets: logging/wireline, drilling, and permanent monitoring. Since transducers sold to permanent monitoring applications rarely return to Quartzdyne, we do not include transducers sold to this market in the denominator. Consider Figure 2, where the cumulative percent returned is defined as:

These percentages are charted versus the age (at return) of the transducer, and sorted by the year built. For example, as shown in Figure 2 the "average" transducer built in 2006 had a 5.4% failure rate after two years in the field, while the "average" 2007 transducer had a 4.5% failure rate after two years in the field. This chart does NOT provide any information concerning the actual time at temperature and pressure. Most of these transducers have been placed downhole in many different locations, and our customers do not provide us a log.

The overall reliability chart shown in Figure 2 includes all failures traced to a Quartzdyne component (crystals, circuit, bellows, etc.) We excluded all returned transducers that qualified for one of the following criteria:

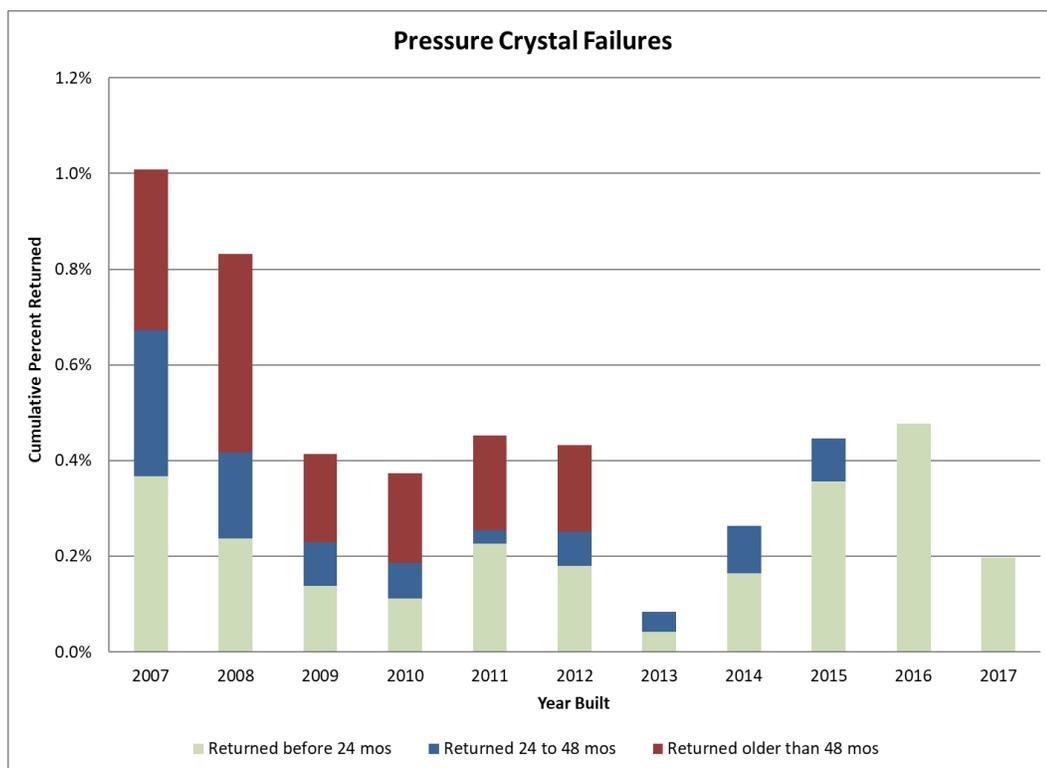
Figure 3: Pressure Crystal Reliability

Historically, quartz pressure (QP) crystal failure rates were around one percent returned. Drive Level Sensitivity (DLS) accounts for roughly 50% of pressure crystal failures. DLS is quantified by measuring the impedance of the resonant frequency at various drive (energy) levels. A set of stable impedance measurements over the drive level set is an indication of an electrically "good" pressure crystal. DLS crystals may exhibit slow or non-startup. DLS may be exacerbated by mechanical shock which could result in a marginal but functioning crystal going intermittent or completely "dead" in the field.

The second most frequent failure mode of pressure crystals (~40%) is high impedance (Hi-Z). Since the oscillator circuit is designed to drive pressure crystals with a specific range of impedances, a Hi-Z crystal simply will not start to oscillate. Hi-Z is often the result of a detached or broken electrical connection from the feed-through to the crystal.

Because a pressure crystal failure results in a scrapped transducer, it is the most expensive failure mode (circuits, temperature, and reference crystals can be replaced). Accordingly, if a transducer is returned with a faulty circuit, but the pressure crystal is also Hi-Z, for example, the failure mode is assigned to the pressure crystal. As such, some of the transducers in Figure 3 may have failed initially for another symptom.

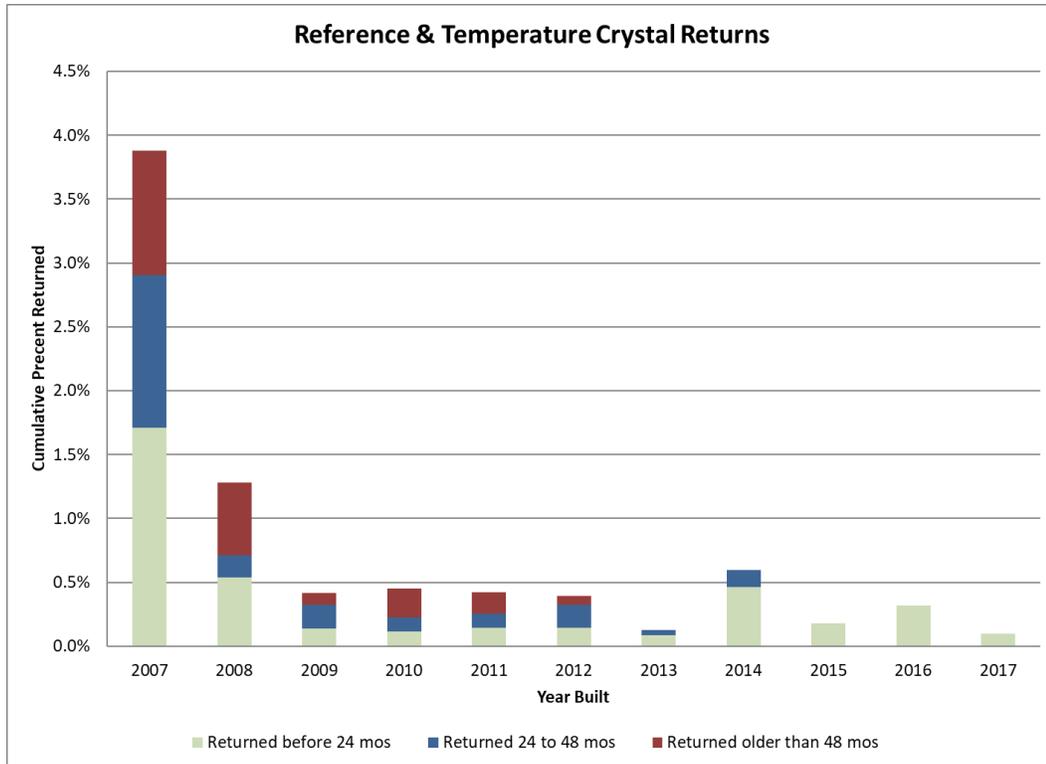
Figure 4: Temperature and Reference Crystal Reliability

When discussing failures of the quartz temperature (QT) and reference (QR) crystals, the same terminology discussed in the Pressure Crystal section applies, namely DLS and Hi-Z. DLS and Hi-Z failures are often caused by severe shocks, where contaminants become dislodged, or the epoxy joints completely fracture. (The conductive epoxy is both the electrical and mechanical attachment of the crystal disc to the metal pins of the TO-5 can.) To make QT/QR crystals that survive drilling vibration, we stiffened the mounting joints inside the TO-5 can in 1999. This improvement has nearly eliminated Hi-Z failures since that time.

Through 2007, DLS remained the primary failure mode of our quartz crystals. We subsequently acquired a scanning-electron microscope (SEM) to help us better understand the source(s) of DLS. It is widely accepted that particle damping is a cause of DLS, and the SEM has helped us identify sources of microscopic particulates. We have attacked DLS failures in two ways:

is over, the AGC shuts off. We've seen a 90% reduction of failures due to DLS QT/QR crystals on units shipped with ASIC hybrids since 2007. (2008 included shipments of both types of circuits.)

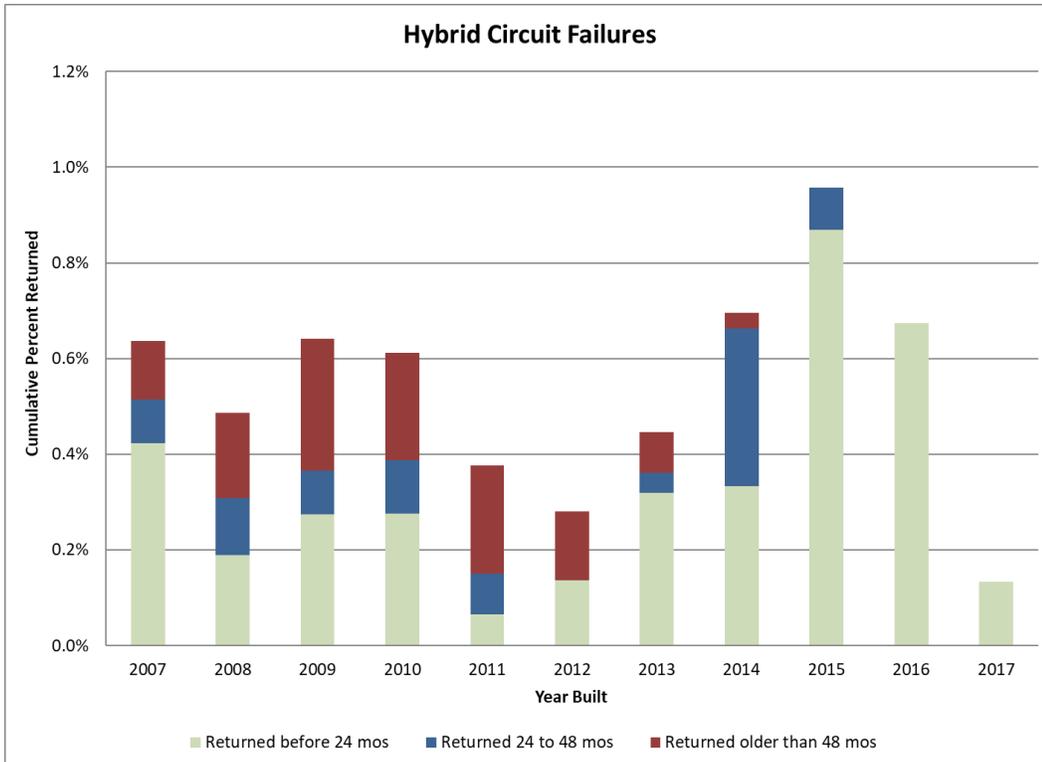
Figure 5: Hybrid Circuit Reliability

Our circuit reliability is based upon our internal testing and field failures. Field failures generally corroborate with failure modes from our internal circuit-life tests. Since surface-mount and hybrid circuits are markedly different technologies, we split out the field-failures of these circuits in Figure 5 and Figure 8. Quartzdyne has written numerous papers on circuit technologies and test methods which are available on our website.

Figure 5 shows the hybrid circuit reliability. Note that hybrids operate in harsher environments than SMT circuits, and their reliability surpasses that of SMT. Hybrid returns are well less than 1% since 2007 when the ASIC oscillator was introduced.

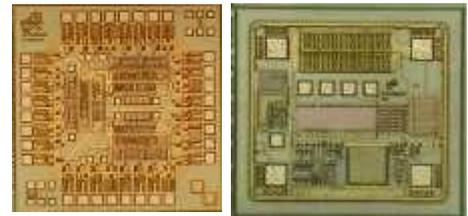
Figure 6: Oscillator, Voltage Regulator and Frequency Counting ASICs improved circuit and sensor reliability.

As mentioned in the QT/QR reliability section, all hybrids now include an AGC. Since an AGC would normally add dozens of components inside the hybrid (for which we had no room), we accomplished it by designing an Application Specific Integrated Circuit (ASIC). ASIC technology allows us to incorporate an AGC without increasing the size of the hybrid circuit. In fact, the oscillator ASIC has improved the reliability of the hybrid circuit as it reduces the total component count inside the hybrid by 50%. Since the ASIC operates on low voltage, it requires a 2.7 – 5.5 VDC supply.

To further reduce component count inside the hybrid, two new ASICs were developed during 2009 at Quartzdyne: a voltage regulator (Vreg) and a frequency counter. The Vreg ASIC enables our hybrids to operate down to a 2.7 VDC minimum supply, and the FC ASIC reduces current draw in digital-output hybrids and allowed us more functionality, such as a 5th byte checksum for data integrity. These two ASICs do the combined functions of 16 discrete components.

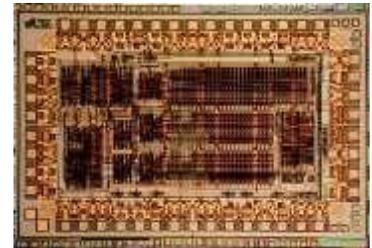
Figure 7: Next generation hybrid circuit. New ASIC eliminates 23 additional parts.

We continue to improve our products by developing application-specific integrated circuits (ASIC) that make our electronics more reliable, higher temperature, and smaller. Our latest ASIC combines three ICs and 23 passives into one chip, reducing the total component count inside the frequency-output (“analog”) hybrid from 29 to 4! This breakthrough took several years to engineer, with a few “re-spins” to fine-tune the ESD protection and crystal oscillation. Due to the reduced component count, the analog circuit has shrunk to one-third of its prior length. Similar results were accomplished for the I2C-output (“digital”) hybrid. The new ASIC helped reduce the component count and size by 50%. The reduced component count and improved packaging also reduced the number of gold wirebonds, a known weak point in the hybrid(s). The new ASIC has survived over 20,000 hours at 275°C, and the accompanying transducers have passed our standard environmental qualification tests. See Figure 7.

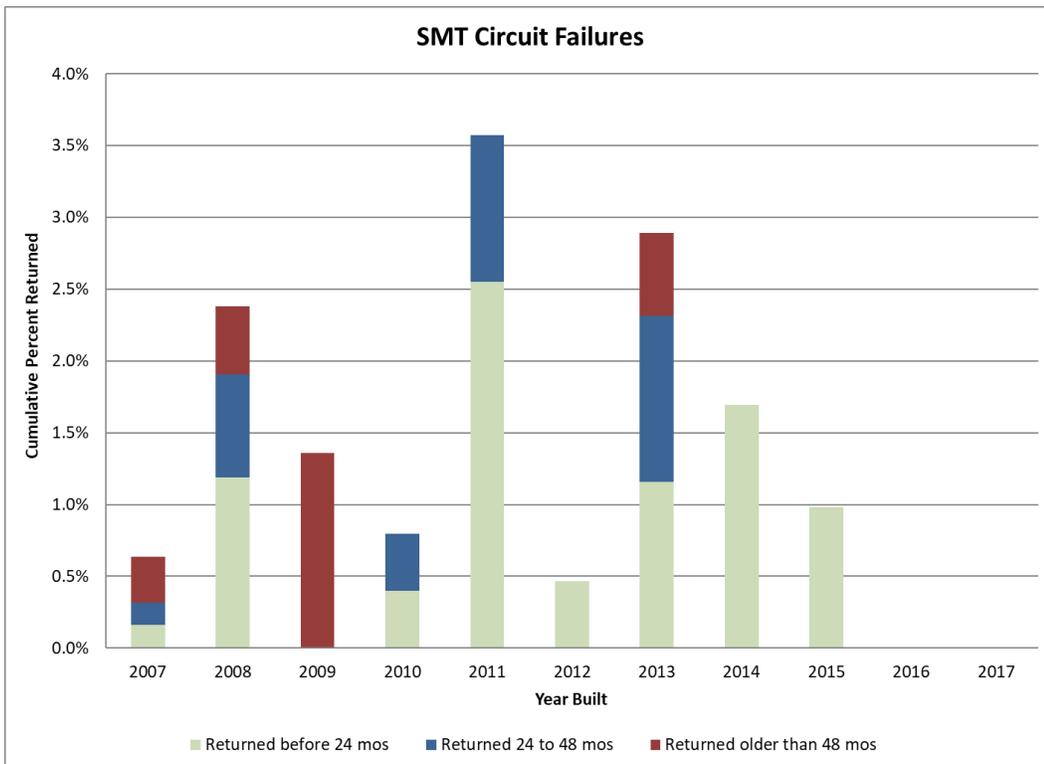
Figure 8: SMT Circuit Reliability

In 2005 most SMT returns were digital-output circuits that demonstrated a problem in the reset logic during startup. Some circuits did not startup properly which could result in a hung bus depending upon the customer's software. We did not discover the problem since our test systems were designed to detect the problem, reset the bus, and try again (per our manual and Phillips I2C recommendations). We revised the digital FPGA firmware in 2006 to eliminate the startup problem. Total SMT returns have been below 2.5% since 2006.

The 2011 increase was primarily due to solder failure on ICs. Most ICs are now supplied with Pb-Free plating which is more susceptible to wetting problems using Sn63 solder. Our internal tests have shown that moving to SAC solder addresses the solder problem and we therefore expect failure rates to decrease to historic 2008-2009 levels (or better).

No SMT returns were recorded in 2016/2017. See Figure 8.

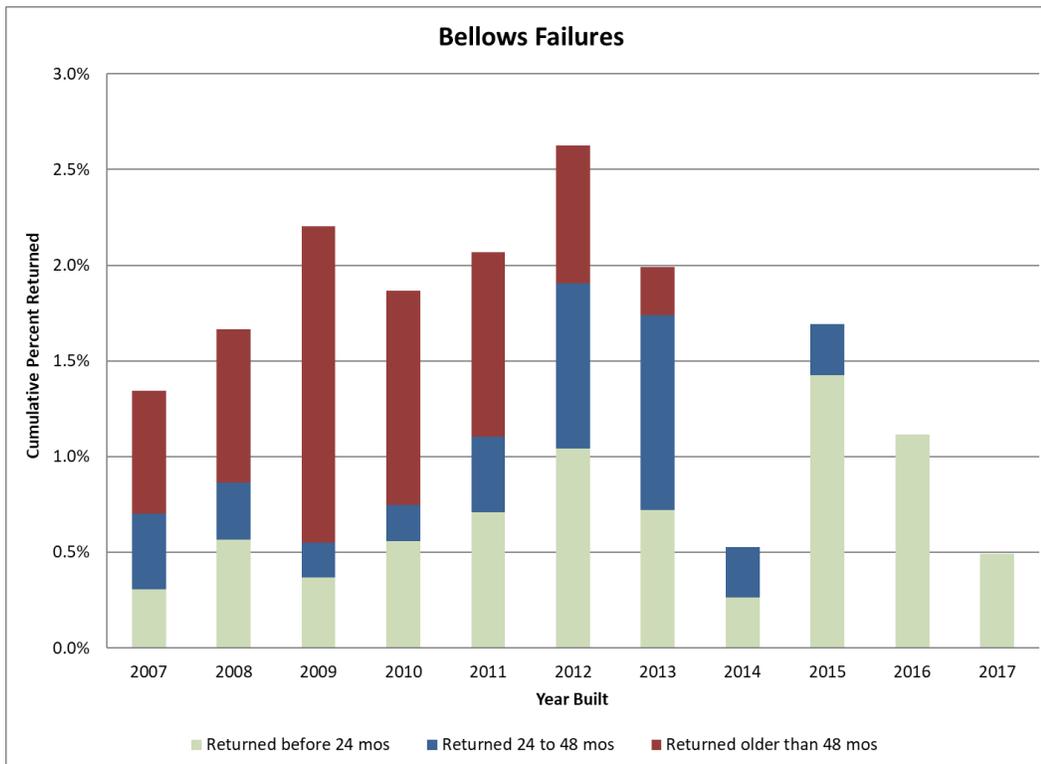
Figure 9: Bellows Reliability

The 2015/2016 increase was largely due to returns for high or low-pressure readings when measuring at ambient conditions. We discovered that products exposed to high temperature without pressure can result in plastic deformation of the bellows. Heating the bellows expands the backfill fluid beyond the elastic range of the metal. When the bellows cool the initial bellows setpoint or height is different causing a high or low reading. This method of testing product goes beyond Quartzdyne's recommended usage. For more information on testing condition contact the Quartzdyne sales department.

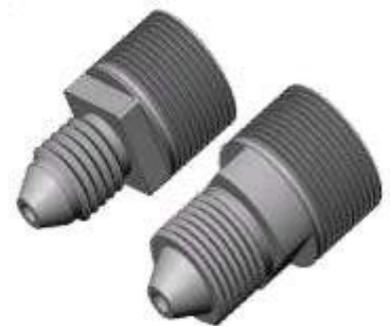
Figure 10: Thread change provided increased reliability for bellows.

In 2005, we became aware of sealing issues with our QMB bellows. This problem was addressed by moving to a larger thread which allowed more torque to provide a better seal – see Figure 10. This improvement was implemented in April 2007.

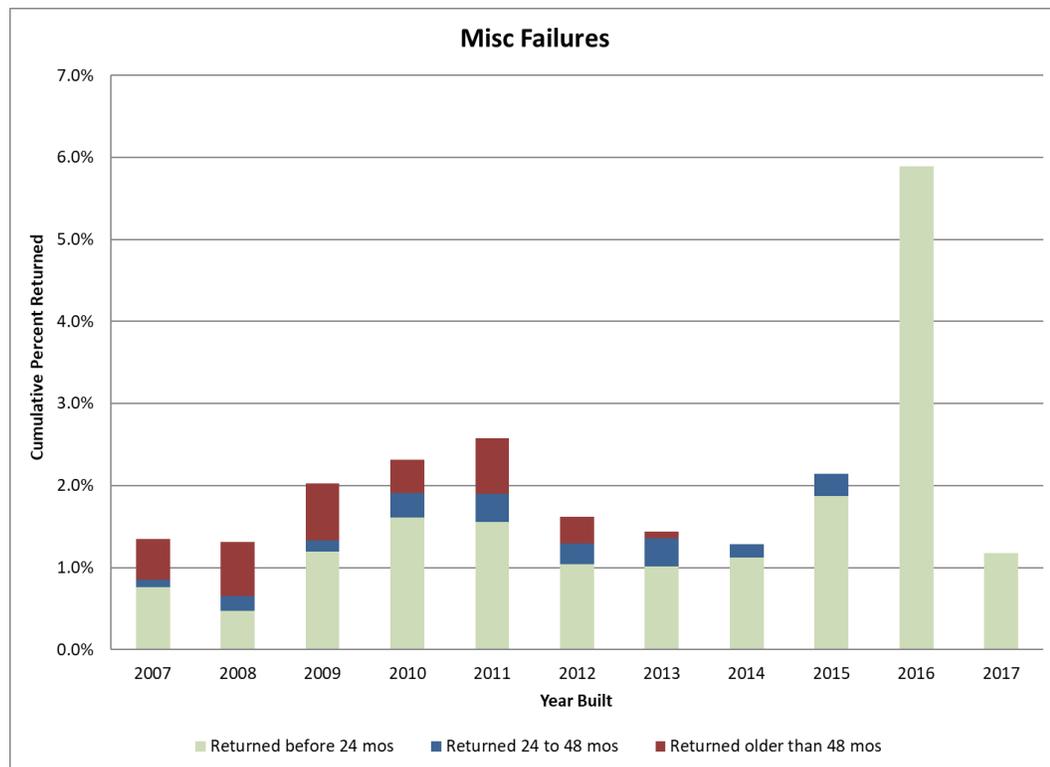
Figure 12: Miscellaneous Failures

The 2016 increase in miscellaneous returns (4.5%) was primarily a combination of dimensional, contamination, recall, mechanical, process, and wiring issues. Almost half (2.2%) are attributed dimensional flaws, oversize or undersize dimensions, missing features, scratches, burrs, etc. 1% of the returns are attributed to a recall relating to a pressure crystal plating issue. After receiving the units none were found to have the plating problem that prompted the recall.
